INTRACORP HOMES

Treatment & Excavation of Japanese Knotweed

1511 W 47th Ave, Vancouver

Japanese knotweed removal

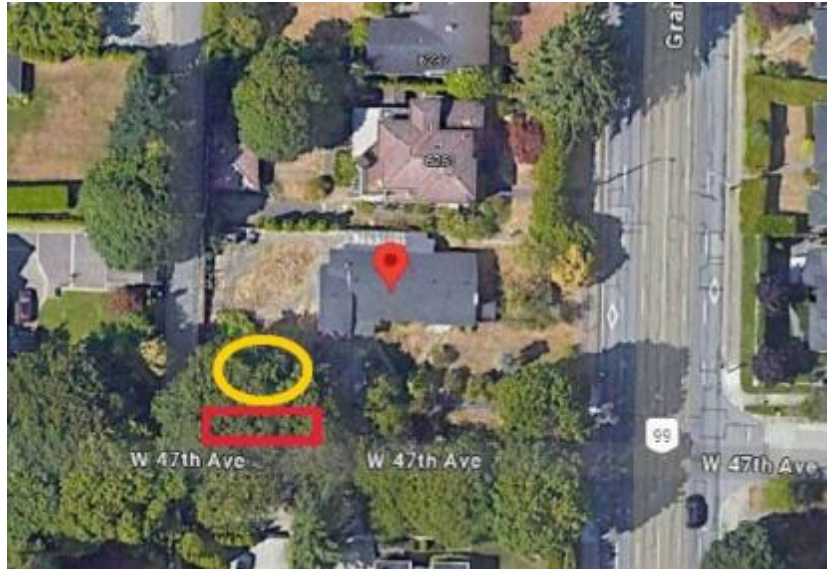
Figure 1: Knotweed that required removal is shown in yellow.

Western Weed Control (WWC) quickly developed a management plan to start the project promptly. The plan included pre-removal herbicide treatment to ensure effective eradication. In June 2024, herbicide was applied to all affected areas, as shown in Figure 1. However, knotweed in the red zone (Figure 1) could not be physically removed due to a protected tree habitat. In July 2024, WWC's experts, along with an excavator operator and dump trucks, carried out the removal in the yellow zone (Figure 1). This involved excavating roots up to 3 meters deep and transporting the material to a disposal facility.

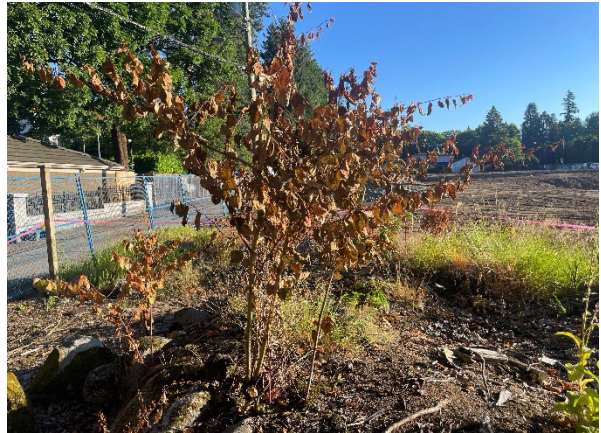
Figure 3 Results after one treatment in June 2024

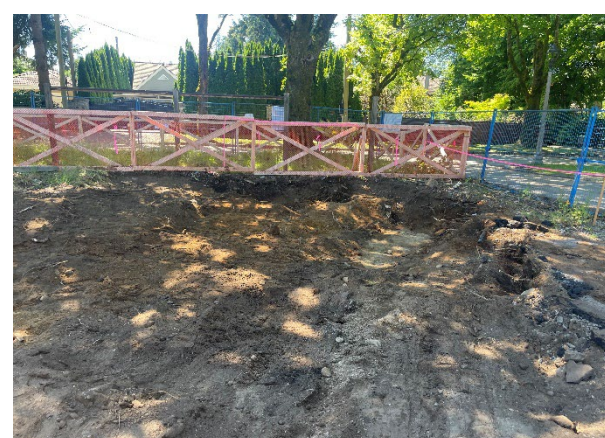
Figure 7 Finished product
